# Manhole Inspection Summary

Manhole # S69K\_\_009MH

Insp Date: **9/1/09 3:36 PM**

**Location** Address: **6614 Hudson St.**

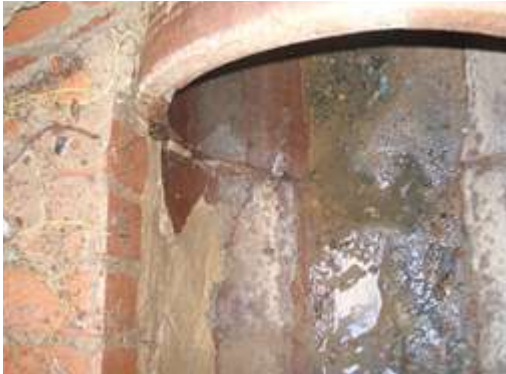
Defect 2

CRACKED PIPE SEAL I6

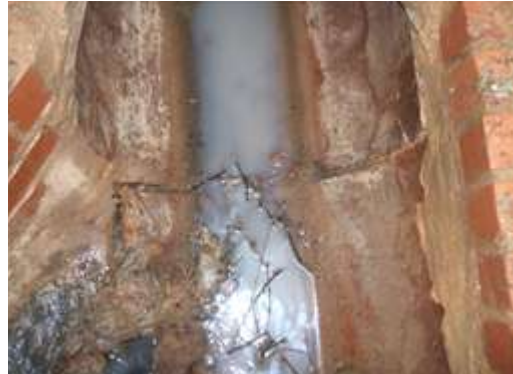
Defect 1

BROKEN PIPE SEAL O12

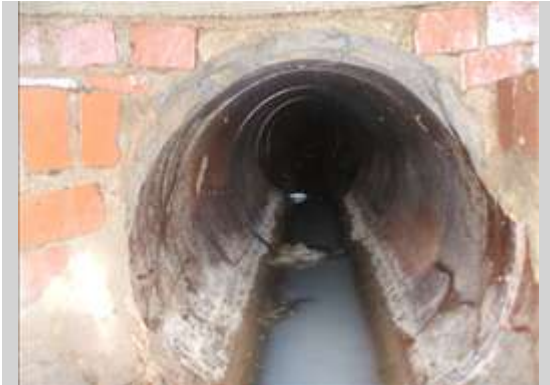
12 O'Clock Outflow

18 in. Circular Gravity Sewer  
Pipe Out @ 12 O'Clock

Infiltration: **Evidence** Pipe Seal Cond: **Cracked**

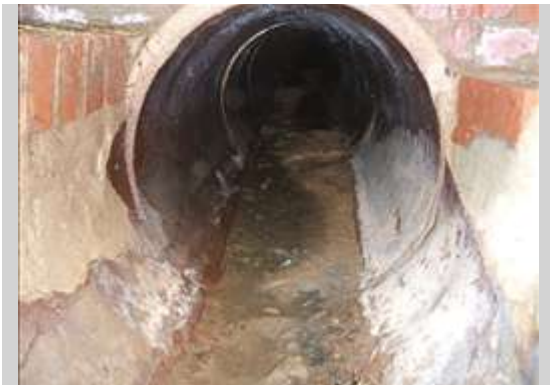
6 O'Clock Inflow

STUB CONNECTION

Infiltration: **Evidence** Pipe Seal Cond: **Broken**

Connects To: **Stub connection / abandoned**

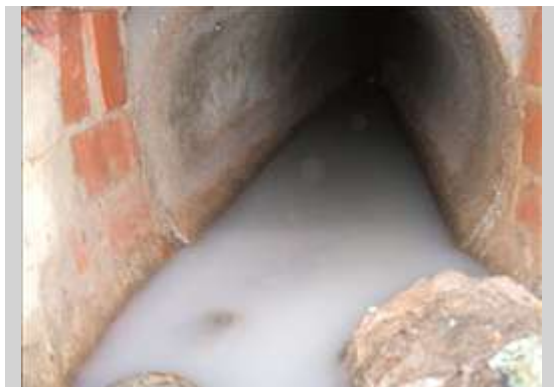
7 O'Clock Inflow

Deposits: ☐ None ☐ Mud ☒ **Sludge** ☐ Debris ☐ Grease

Silt Depth: **2** (in.) Deposits Extent: **Light**
